Effect of protective cladding on the fire performance of vertically loaded cross-laminated timber (CLT) wall panels

Muhammad Yasir, Andrew Macilwraith, Conan O'Ceallaigh & Kieran Ruane

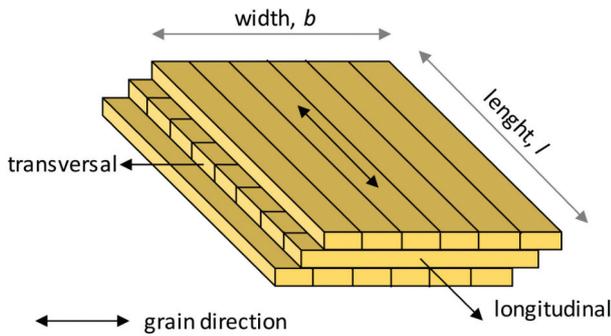
Figure 1. A three-layer CLT panel (Sandoli et al., 2021).

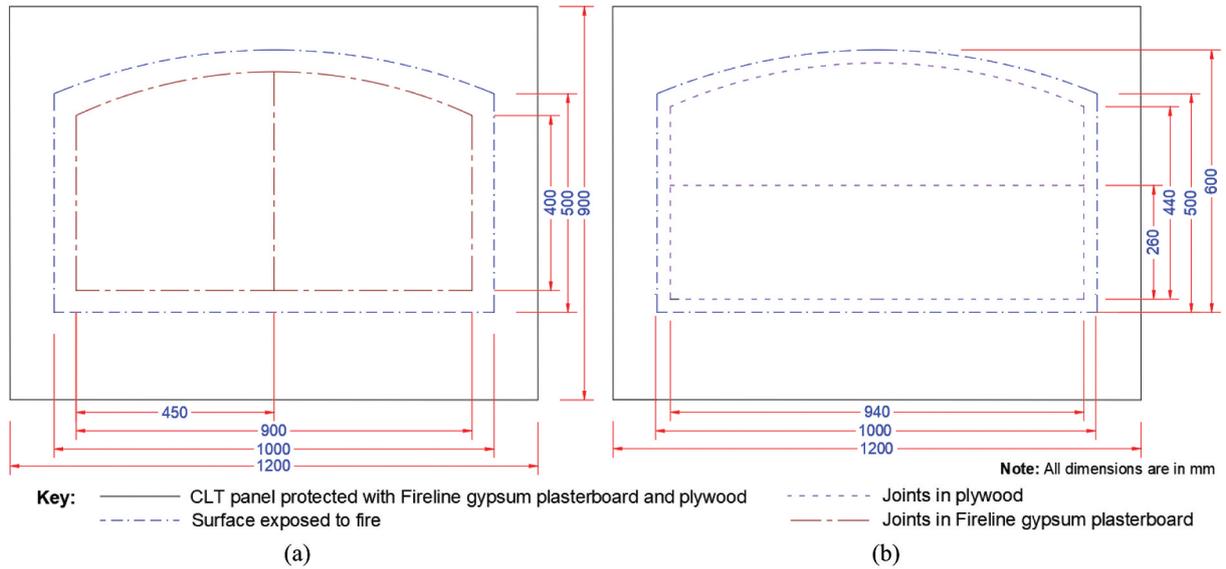
Figure 2. Location of joints in the protective claddings of W-12.5FP25PW panel, (a) Joints location in Fireline gypsum plasterboard, placed between CLT panel and plywood, (b) Location of joints in the outer plywood layer.

at 50 mm and 30 mm inside the furnace perimeter in the gypsum plasterboard and plywood respectively as shown in Figure 2. The main idea of these joints was to mimic the protective claddings falling off during a fire. These different types of CLT panels are illustrated in Figures 3–5. In all the test panels, the surface that is directly exposed to fire is 1000 mm wide x 600 mm high as represented in Figure 3.

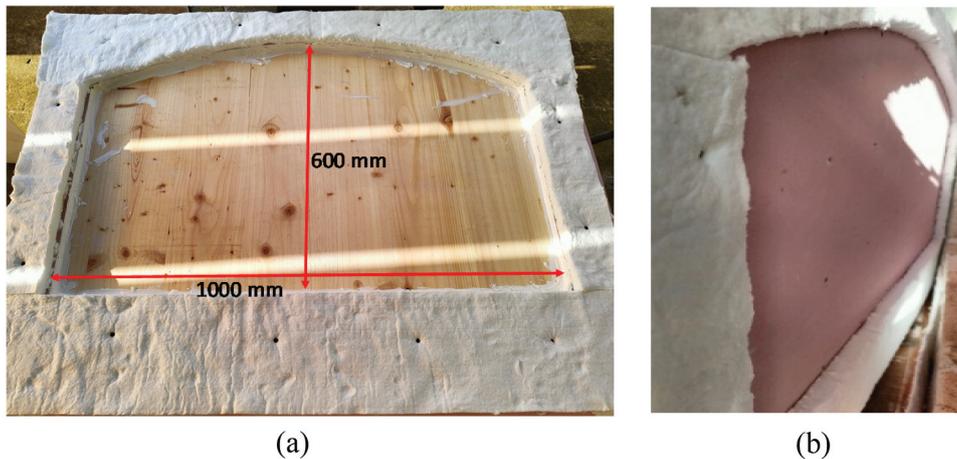
Figure 3. (a) Unprotected CLT panel (W-1), (b) CLT panel protected with 15 mm Fireline gypsum plasterboard without joints (W-15FP).

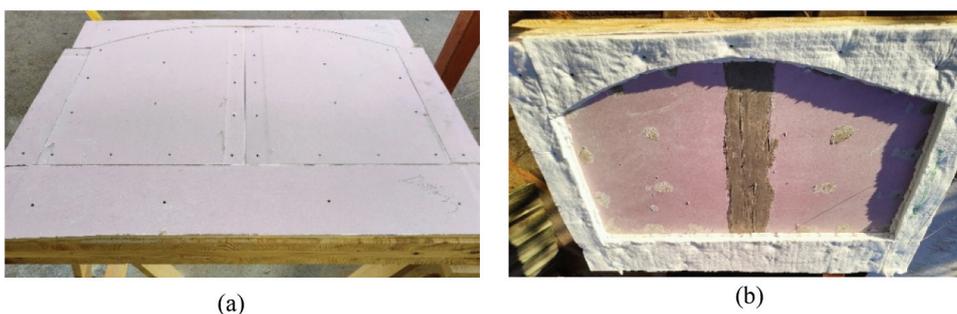
Figure 4. CLT panel protected with 15 mm Fireline gypsum plasterboard with a vertical joint and a joint inside the perimeter (W-15FPJ), (a) Joints are visible, (b) Joints are sealed and the panel is ready to be placed in the furnace.

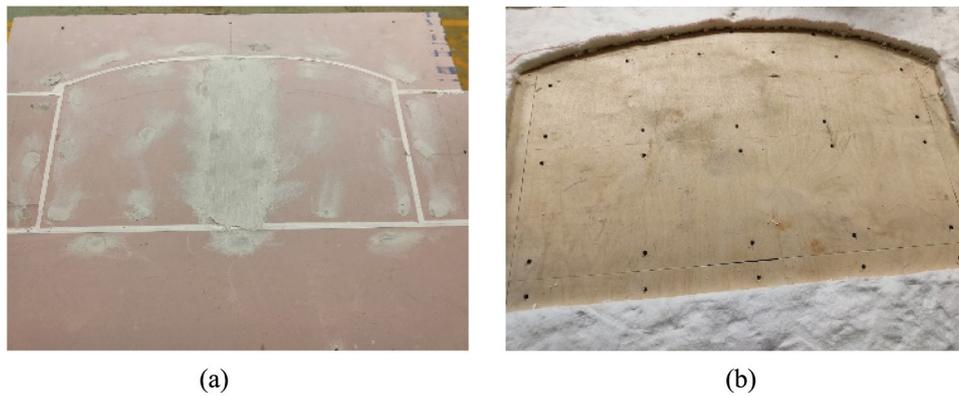
Figure 5. W-12.5FP25PW, (a) 12.5 mm Fireline gypsum plasterboard with joints placed between the CLT panel and the outer plywood layer, (b) Exposed 25 mm plywood layer with joints.

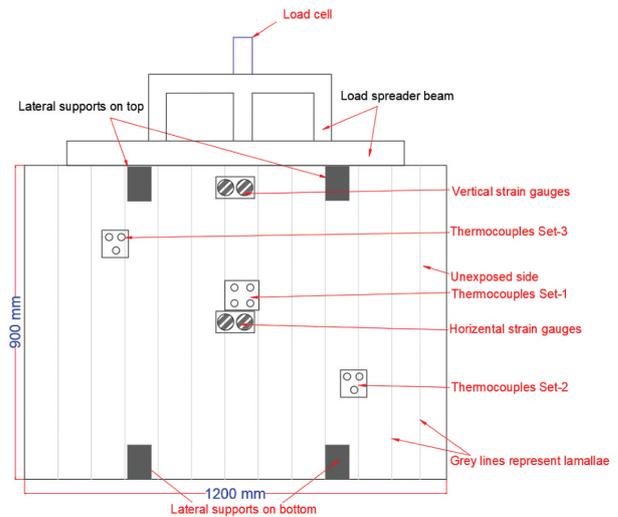
Figure 7. Drawing of the CLT panel set-up against the furnace.

Each wall panel was placed up against the front of the fire testing furnace, with the furnace door swung to one side. The CLT test panel was held up against the furnace with a steel frame on the unexposed side of the panel as shown in Figures 6 and 7. Timber packing pieces were placed between the frame and the CLT panel at the top and the bottom of the panel. The load cell on the top of the panel recorded the applied constant vertical load of 85 kN throughout the test. The load was applied using a steel spreader beam along the top of the panel. A deflection gauge at the mid-span of the panel was placed to measure the horizontal displacement throughout the testing. The furnace was also equipped with a propane gas burner which was manually controlled to ensure the ISO 834 standard fire curve (1999) was followed for heating conditions in the furnace. In all of these panels, fasteners with a length of 60 mm were used for the panel protected with one layer of cladding. In the panel, which was protected with two layers of protective claddings, the length of the fasteners used were 60 mm and 70 mm for the inner and outer claddings respectively. In all of these tests, the fasteners were embedded in the CLT wall panel by approximately 45 mm.

The spacings between the fasteners were kept at 180 mm for the fasteners on the perimeter of the cladding, while the internal spacings were kept at 250 mm.

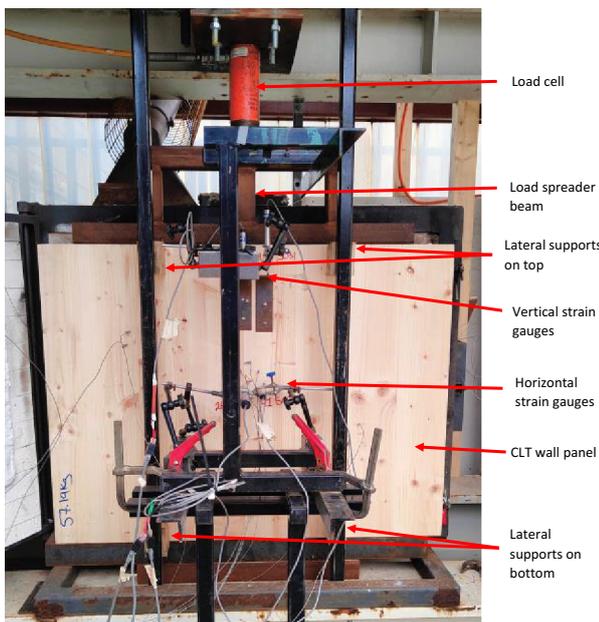
Figure 6. A test panel up against the furnace opening showing the side of the panel not exposed to fire.

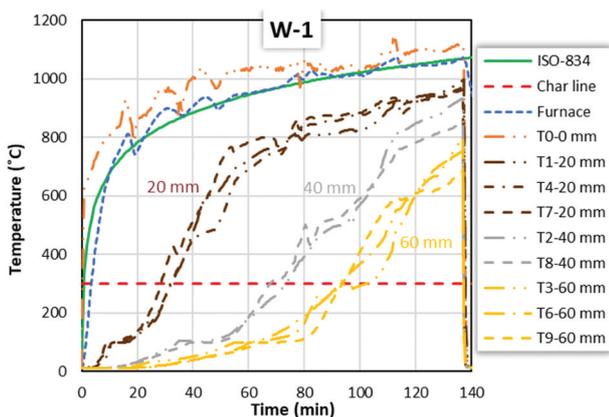
Figure 8. Temperature-time curves of test specimen W-1 at different depths based on TC locations.

The furnace temperatures recorded by the plate thermometer and the temperatures measured by different K-thermocouples installed at various depths are shown in Figure 8. As can be seen in this Figure 8, the different sets of K-thermocouples installed at the same depth but at different locations in the CLT panels gives similar temperature distribution throughout the test. Also, the furnace temperature closely followed the Standard ISO 834 fire curve throughout the test.

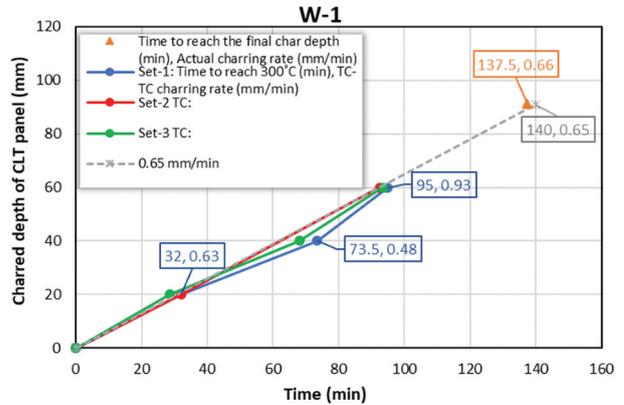
Figure 9. TC-TC charring rate of test specimen W-1.

The charring rates of the W-1 panel at different depths are shown in Figure 9. The charring rate of the unprotected wall panel was in the range of 0.63–0.66 mm/min which is very close to the one-dimensional charring rate tabulated in Eurocode 5 (Bartlett et al., 2015). It can be observed that in an unprotected CLT wall panel (W-1), the charring rate for the first 20 mm thickness of the CLT panel from the exposed face to fire was 0.63 mm/min. However, the charring rate for the next 20 mm of the CLT panel (until reaching the interface between layers 1 & 2) was reduced to 0.48 mm/min. The decrease in the charring rate could be due to the protective char layer preventing the heating up of the panel directly beneath it. In layer-2 of the W-1 panel, the charring rate increased significantly to 0.93 mm/min, due to the fact that some of the char of layer-1 has fallen-off when the interface temperature between the two layers reached the char temperature (300°C). Furthermore, the gaps between the individual lamellae increase causing the heat to move through the opening of the lamellae of the panel. There was no delamination or fall-off of the entire layer of the CLT panel during the test as shown in Figure 10. The charred depth of 91 mm was measured after the fire test time of 137.5 mins which gives an overall charring rate of 0.66 mm/min.

In Figures 9, 12, 14 and 17, the time to reach the final char depth based on the actual measurements after the test, and the charring rates calculated between the locations of the thermocouples, are both given. The final char depths of the panels are measurements at the location of maximum char after the fire tests were finished. The actual charring rate was calculated by taking the ratio of the maximum charred depth and total fire time of the test. For specimen W-1, the charred rate calculated using Set-1 TC is 0.63 mm/min while the charring rate calculated after measuring the final charring depth was 0.66 mm/min. For specimens W-15FP, W-15FPJ, and W-12.5FP25P, the charring rates calculated from the installed thermocouples (Set-1 TC) were 0.35, 0.37, and 0.56 mm/min respectively. The charring rate calculated after the actual measurement of charred depth for these specimens was 0.44, 0.46 and 0.67 mm/min. The actual charred depth is slightly higher than the charring depth calculated from the data recorded by thermocouples due to the following reasons:

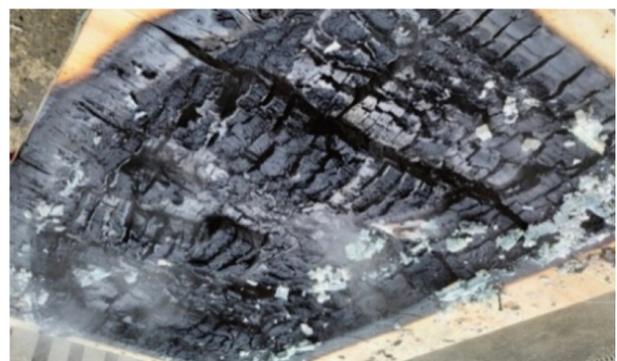
Figure 10. W-1 panel after the fire test showing pieces of localized char fall-off.

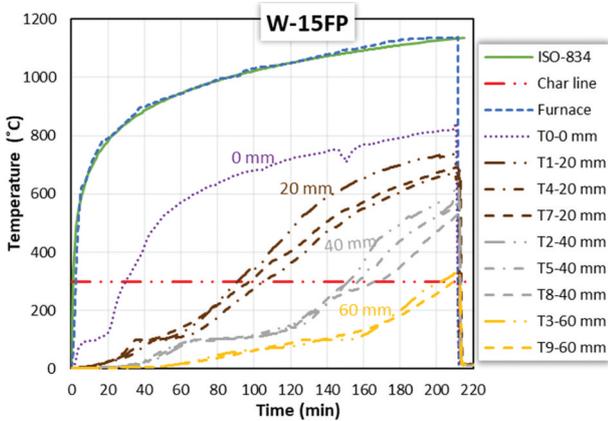
Figure 11. Temperature-time curves of test specimen W-1 at different depths based on TC locations.

W-15FP. The furnace temperatures and the temperatures measured at various depths within the CLT panel, protected with a 15 mm Fireline gypsum plasterboard with no joints in it, are shown in Figure 11. The different sets of K-thermocouples installed at the same depth but at different locations in the CLT panels give similar temperature distribution throughout the test. The furnace temperature closely followed the Standard ISO 834 fire curve throughout the test.

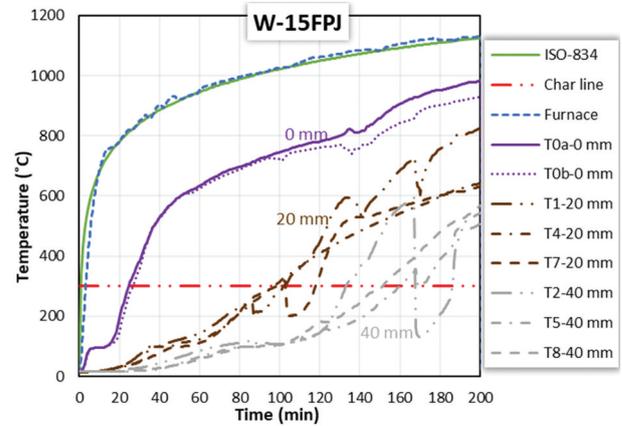
Figure 13. Temperature-time curves of test specimen W-15FPJ at different depths based on TC locations.

W-15FPJ. The furnace temperatures and the temperatures measured at various depths within the CLT panel, which was protected with a 15 mm Fireline gypsum plasterboard with joints in it, are shown in Figure 13. The furnace temperature closely followed the Standard ISO 834 fire curve throughout the test.

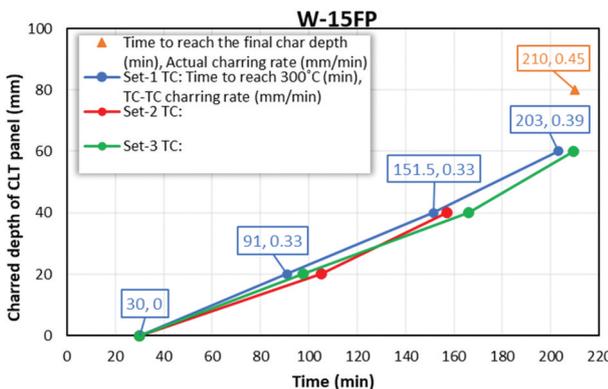
Figure 12. TC-TC charring rate of test specimen W-15FP.

The charring rate calculated from TCs data and from the residual uncharred cross-section of the CLT panels is illustrated in Figure 12. In W-15FP, the charring rate for the first 20 mm of the CLT panel was low at 0.33 mm/min as shown in Figure 12. The charring rate remained constant throughout the depth of layer 1 (40 mm depth) at 0.33 mm/min. However, the charring rate slightly increased to 0.39 mm/min in the first 20 mm of layer-2 at 60 mm depth from the face of the panel near to the fire. From Figure 12, it can be seen that the slope of charred depth vs time curve is almost constant throughout the test due to the fact that the cladding of 15 mm Fireline gypsum plasterboard remained intact on the panel. The charred depth of 80 mm was measured after the fire test time of 210 mins which gives a charring rate of 0.45 mm/

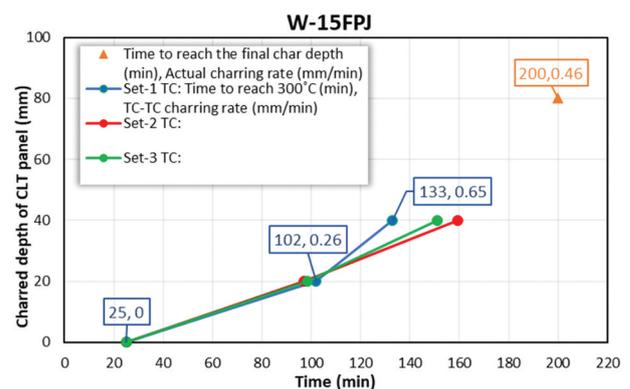
Figure 14. TC-TC charring rate of test specimen W-15FP.

In W-15FPJ, the charring rate for the first 20 mm of the CLT panel was quite low at 0.26 mm/min as shown in Figure 14. However, the charring rate for the next 20 mm of the W-15FPJ increased substantially to 0.65 mm/min which could be due to the opening of the vertical joint in the cladding causing the heat to be directed into the CLT panel at that location. This can also be confirmed by the different sets of TCs installed at the same depths but at different locations as illustrated in Figure 14. The charring rates measured by Set-2 and Set-3 thermocouples remained almost constant throughout the test. The charred depth of 80 mm was measured after the fire test time of 200 mins which gives a charring rate of 0.46 mm/min as shown in Figure 15. The protective cladding of the Fireline gypsum plasterboard remained intact on the CLT panel throughout the test. This kept the charring of the CLT panel low as fall off of CLT layers did not occur.

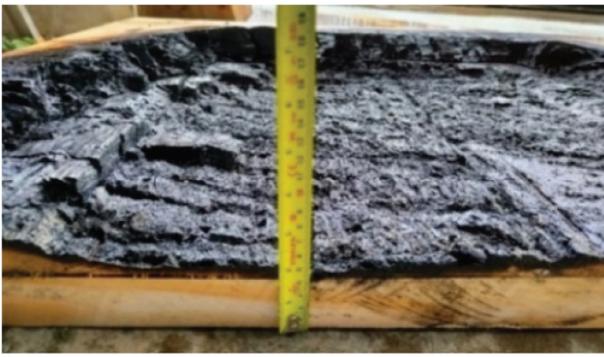
Figure 15. Measurement of uncharred depth.

The charring rate is the charred depth divided by the time in which the temperature at a certain depth reaches 300°C. The charring rate and charred depth were measured in two ways. The first method was to remove the panel from the furnace after the test has finished, cool down the specimen with water and then measure the charred depth. Using this method, the overall charring rate is calculated after the tests were finished based on the measured charred depth and the total fire time. The second technique was the installation of thermocouples at the mid-depth of each layer and in the joints between layers. The charring of the panel at a specific depth was considered to have commenced when the temperature of the thermocouples reached 300°C. The temperature recorded by TCs installed at various depths of the CLT panels was used to calculate the charred depth over time which in turn gives the charring rate. The charring rates measured by the Set-1 TC were used for the comparison with the actual charring rates as the maximum char depth was measured at the location close to Set-1 TCs.

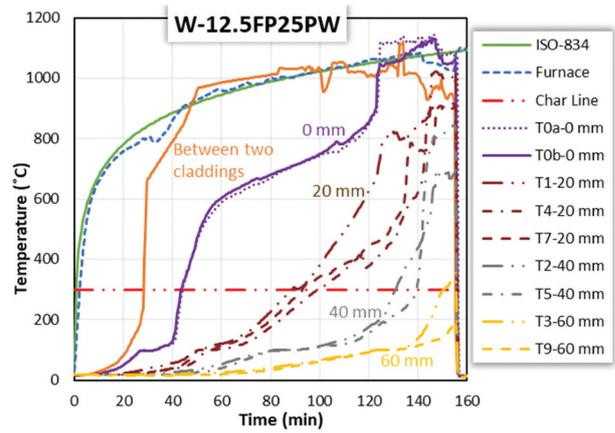
Figure 16. Temperature-time curves of test specimen W-15FPJ at different depths based on TC locations.

a 25 mm plywood layer with joints in both, are shown in Figure 16. A slight reduction in the furnace temperature at 20–40 mins of the test was observed but overall, the furnace temperature closely followed the Standard ISO 834 fire curve throughout the test.

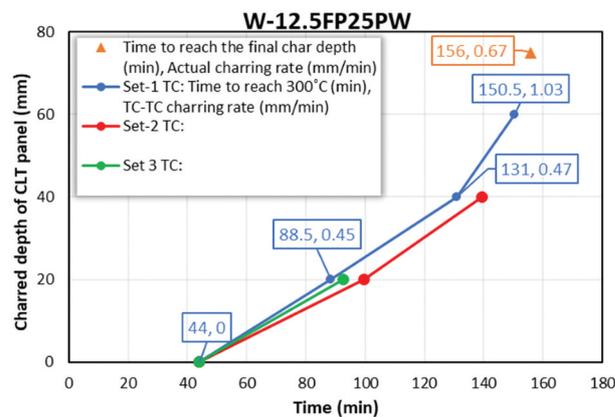
Figure 17. TC-TC charring rate of test specimen W-12.5FP25PW.

In this wall panel W-12.5FP25PW, the initial charring rate for the first 20 mm of the panel was 0.45 mm/min which then slightly increase to 0.47 mm/min up to the 40 mm depth of the panel as shown in Figure 17. In CLT layer 2 of W-12.5FP25PW, the charring rate increased significantly to 1.03 mm/min which might be due to the fall-off of a charred layer 1 which exposed the fresh timber of layer 2 directly to the fire.

In W-12.5FP25PW, the slope of the charred depth and time curve is almost constant for the first 40 mm depth of the CLT panel. However, the slope of the charring depth time curve increased significantly after 40 mm of the CLT panel was charred. This is because the cladding which was intact with the CLT panel for more than 120 mins of the test then fell off which directly exposed the CLT panel to the fire. Furthermore, after the removal of the CLT panel from the furnace, it was observed that the fire-exposed layer of the CLT panel was delaminated during the test as shown in Figure 18. The charred depth of 75 mm was measured after the fire test time of 156 mins which gives a charring rate of 0.67 mm/min.

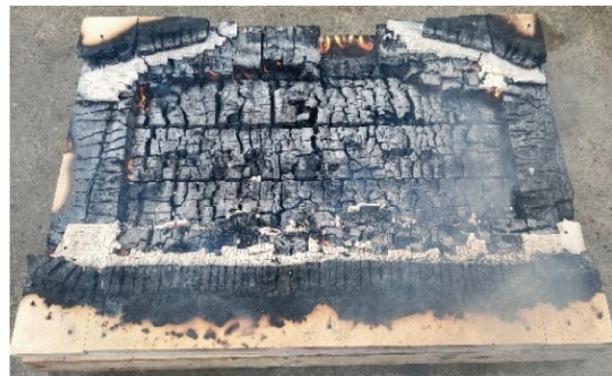
Figure 18. A photo was taken after the test showing the fall-off of cladding and outer layer of CLT panel: W-12.5FP25PW.

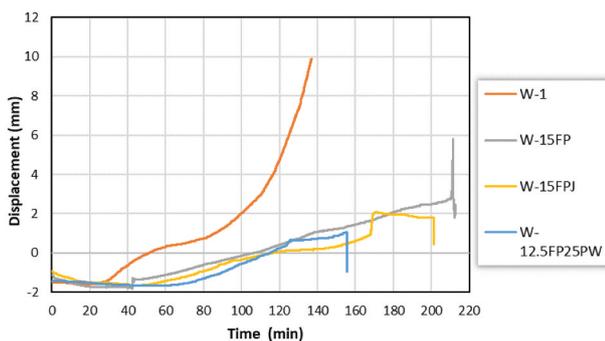
Figure 19. Deflection at mid-height versus time for test panels when exposed to fire.

All the fire tests were stopped due to the integrity failure in which the fire from the edges of the panel broke through except for the W-1 panel. An excessive deflection was observed in the W-1 panel as soon as the third layer of the panel started charring. The rest of the test panels which were protected with different cladding configurations were stopped before any structural failure could occur in which the panels are unable to sustain the load. The horizontal mid-height deflection on the un-exposed face of the panel to fire was recorded and is shown in Figure 19. In wall panel W-1, which was directly exposed to fire, the deflection increased at the beginning and was followed by a plateau and then a more abrupt increase in the deflection. The initial increase in deflection was due to the charring of the fire-exposed outer load-bearing layer. The plateau shows the charring of the inner weak layer (perpendicular to the grain) that is followed by an increase in deflection due to the charring of the third vertically load-bearing layer. In the panels which were initially protected by cladding, the deflection time curves are similar to the un-protected panel except that the plateau was observed earlier due to the protection provided by the cladding on the exposed side to fire.

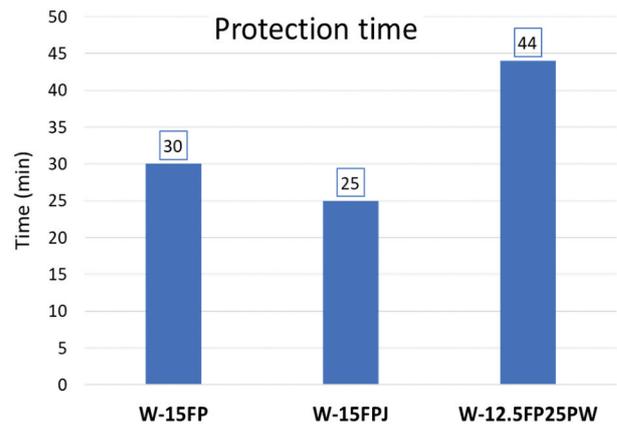
Figure 20. Delaying in charring of CLT panels (in minutes).

The delay in charring of CLT panels provided by different protective cladding configurations is given in Figure 20. The protective cladding in W-15FP delayed the charring of the CLT panel by 30 mins when it was protected by a 15 mm Fireline gypsum plasterboard (Type F) with no joints. While, in panel W-15FPJ, the charring of the CLT panel was delayed

by 25 mins, when it was protected with a 15 mm Fireline gypsum plasterboard with joints. EN 1995-1-2 provides the formulae as given in Equation 1 to measure the start of charring of the CLT panel behind the gypsum type A or F plasterboards at internal locations or the perimeter adjacent to filled joints. The delay in charring of the CLT panels (t_{ch}) calculated using Equation 1 for type F plasterboards with 15 mm thickness is 28 mins, which is very close to the experimental values of 25 mins and 30 mins as calculated in this research for 15 mm thick Type F plasterboard.

The overall delay in charring of the CLT panel was 44 min in W-12.5FP25PW, which was protected with a 12.5 mm Fireline gypsum plasterboard and a 25 mm plywood layer. The temperature behind the plywood reached 300°C in 28 minutes, which shows that the 25 mm plywood layer can significantly contribute to the delay of charring of the CLT panel. The charring rate of the plywood layer was found to be 0.89 mm/min which compares well to the one-dimensional charring rate of 1 mm/min provided by EN 1995-1-2 for the plywood panel having a thickness of 20 mm or more with a characteristic density of 450 kg/m³. However, it is important to note that the system presented above, inclusive of plywood and plasterboard, influences this result, and further testing is required to verify the delay in charring that could be achieved with plywood as the sole protective layer of load-bearing elements.

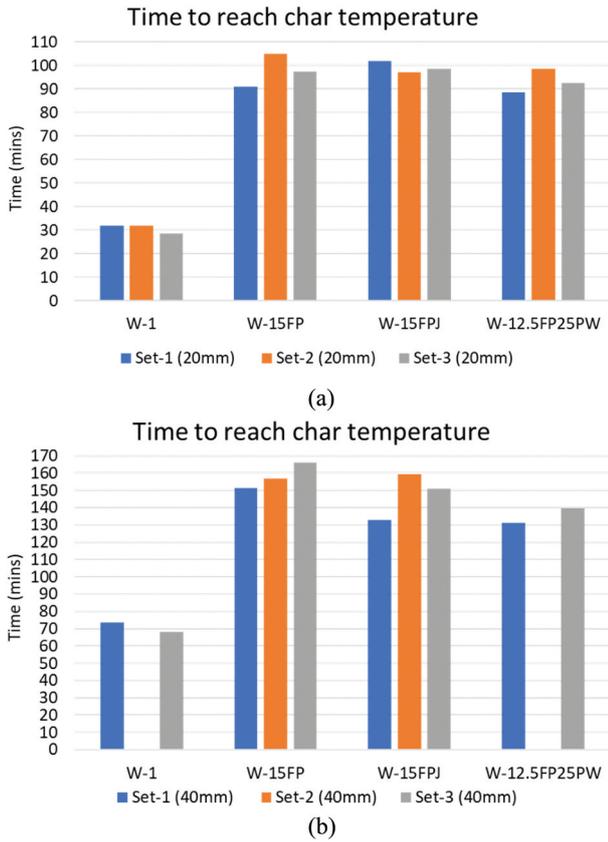
Figure 21. Time to reach char temperatures at different TC-sets, a. 20 mm from exposed face b. 40 mm from the fire-exposed face of the CLT panel (excluding the thickness of the protective cladding).

The three sets of thermocouples, which were drilled into the CLT panels at a similar depth from the exposed face to the fire but at different locations are compared in terms of the time to reach the charring temperature and are shown in Figure 21. Overall, all three sets of thermocouples gave similar times to reach the char temperature ranging from 2 mins to 15 mins except for the 40 mm readings of W-15FPJ where the difference between the time to reach the char temperature was up to 26 mins. In the W-15FPJ panel, the vertical joint in the Fireline gypsum plasterboard appears to open as can be seen in Figure 22. This caused the heat to pass through the joint directly and in turn, the temperature of the set-1 thermocouple (placed at a depth of 40 mm from the face of the CLT panel near the fire) increases more rapidly. On the other side, the two thermocouples at 40 mm from set-2 and set-3

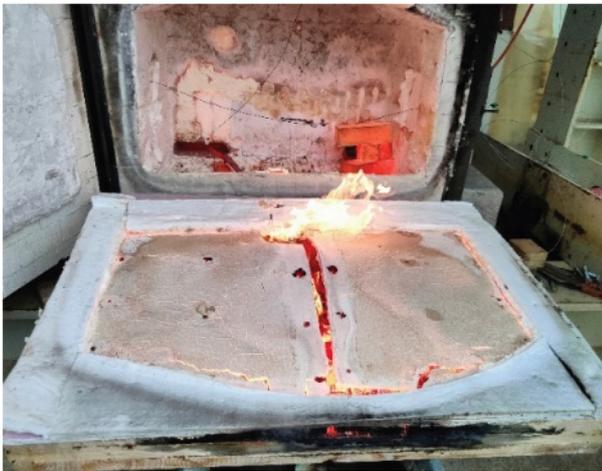
Figure 22. Fireline gypsum plasterboard remaining in place for the duration of the test W-15FPJ.

were protected from direct exposure to fire as the plasterboard was in contact with the panel throughout the test.

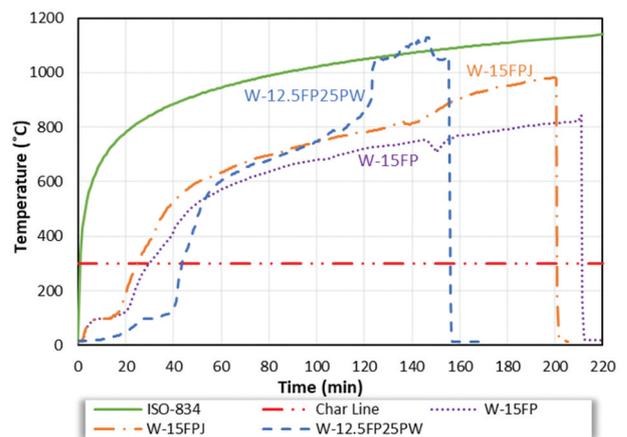
Figure 23. Temperature variation between the plasterboard and CLT panels.

The effect of the joint location of the protective cladding on the fire performance of the CLT panel was studied. The W-15FP panel, which had no joint in the plasterboard remained in contact with the CLT panel throughout the test. The temperature measured and recorded by the thermocouple placed between the CLT panel and the plasterboard showed a lower temperature than the furnace temperature throughout the test. Thus the

direct contact between the plasterboard and the CLT panel gave extra protection to the panel and consequently resulted in the lower char depth. Similarly, in Specimen W-15FPJ the measured temperature behind the protective cladding was lower than the furnace temperature throughout the test as shown in Figure 23 resulting in a lower char depth. In W-12.5FP25PW, which was protected with 25 mm plywood and 12.5 mm Fireline gypsum plasterboard, both with joints, resulted in the fall off of the cladding during the test. Due to the fall off of the cladding, the temperature recorded by a thermocouple placed between the plasterboard and CLT panel reached the furnace temperature resulting in a higher charring rate due to the direct exposure of the CLT panel to fire. The temperature-time curves recorded by the thermocouples which are installed between the CLT panel and the Fireline gypsum plasterboard are shown in Figure 23. It can be seen from Figure 23, that in specimen W-15FP the temperature between the plasterboard and the CLT panel was less than the temperature recorded by thermocouples in W-15FPJ and W-12.5FP25PW. In specimen W-15FPJ, the temperature recorded between the plasterboard was slightly higher than the W-15FP panel at the first 2.5 hours of the test. In the W-12.5FP25PW specimen, the temperatures between the protective claddings and CLT panel followed a similar trend to that of the W-15FP and W-15FPJ panels for the first 2 hours of the test. However, a sharp increase in the temperature between the plasterboard and CLT panel was observed at around 120 minutes into the W-12.5FP25PW test and consequently, the temperature between the plasterboard and the CLT panel reached the furnace temperature. This sudden increase in the temperature behind the protective claddings at around 2 hours of the test shows that the fall-off of the plasterboard occurred at that time.
