## Structural evaluation of castellated timber *I*-joists

A.M. Harte\*, G. Baylor

Civil Engineering, College of Engineering and Informatics, National University of Ireland, Galway, Ireland

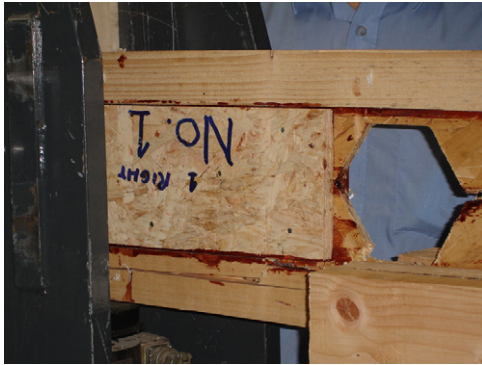
Fig. 4. Solid end section.

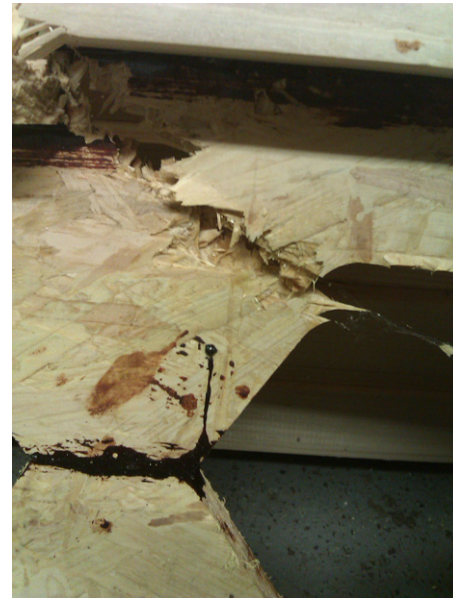
Fig. 8. Tension failure at corner of opening.

Two modes of failure occurred, namely, tension failure in the web at the top or bottom corners of the openings ( $T$ ) or a shear failure in the web at mid-depth either beside or in the finger joint ( $S$ ). For the case of the tension failure, a crack developed from the corner of the opening to the flange. The crack angle varied between  $30^\circ$  and  $45^\circ$  to the horizontal. In all cases, failure occurred suddenly. Where two failure modes occurred, it was not possible to tell which mode of failure occurred first. Examples of both modes of failure can be seen in Figs. 7 and 8. Tension failure at the corners of openings has been commonly reported in the literature [6–8]. Shear failure of web weld between openings has been reported in steel castellated joists [3,4] while Zhu [8] reported web shear failures in timber  $I$ -joists with closely spaced openings. There was no evidence of web buckling during the tests as has been found with both steel and timber joists. This is due to the low web depth to width ratio.
